REPORT OF INVESTIGATION
Underground Coal Mine

Fatal Fall of Rib Accident
February 15, 2003

Wabash Mine
Wabash Mine Holding Company
Keensburg, Wabash County, Illinois
I. D. No. 11-00877

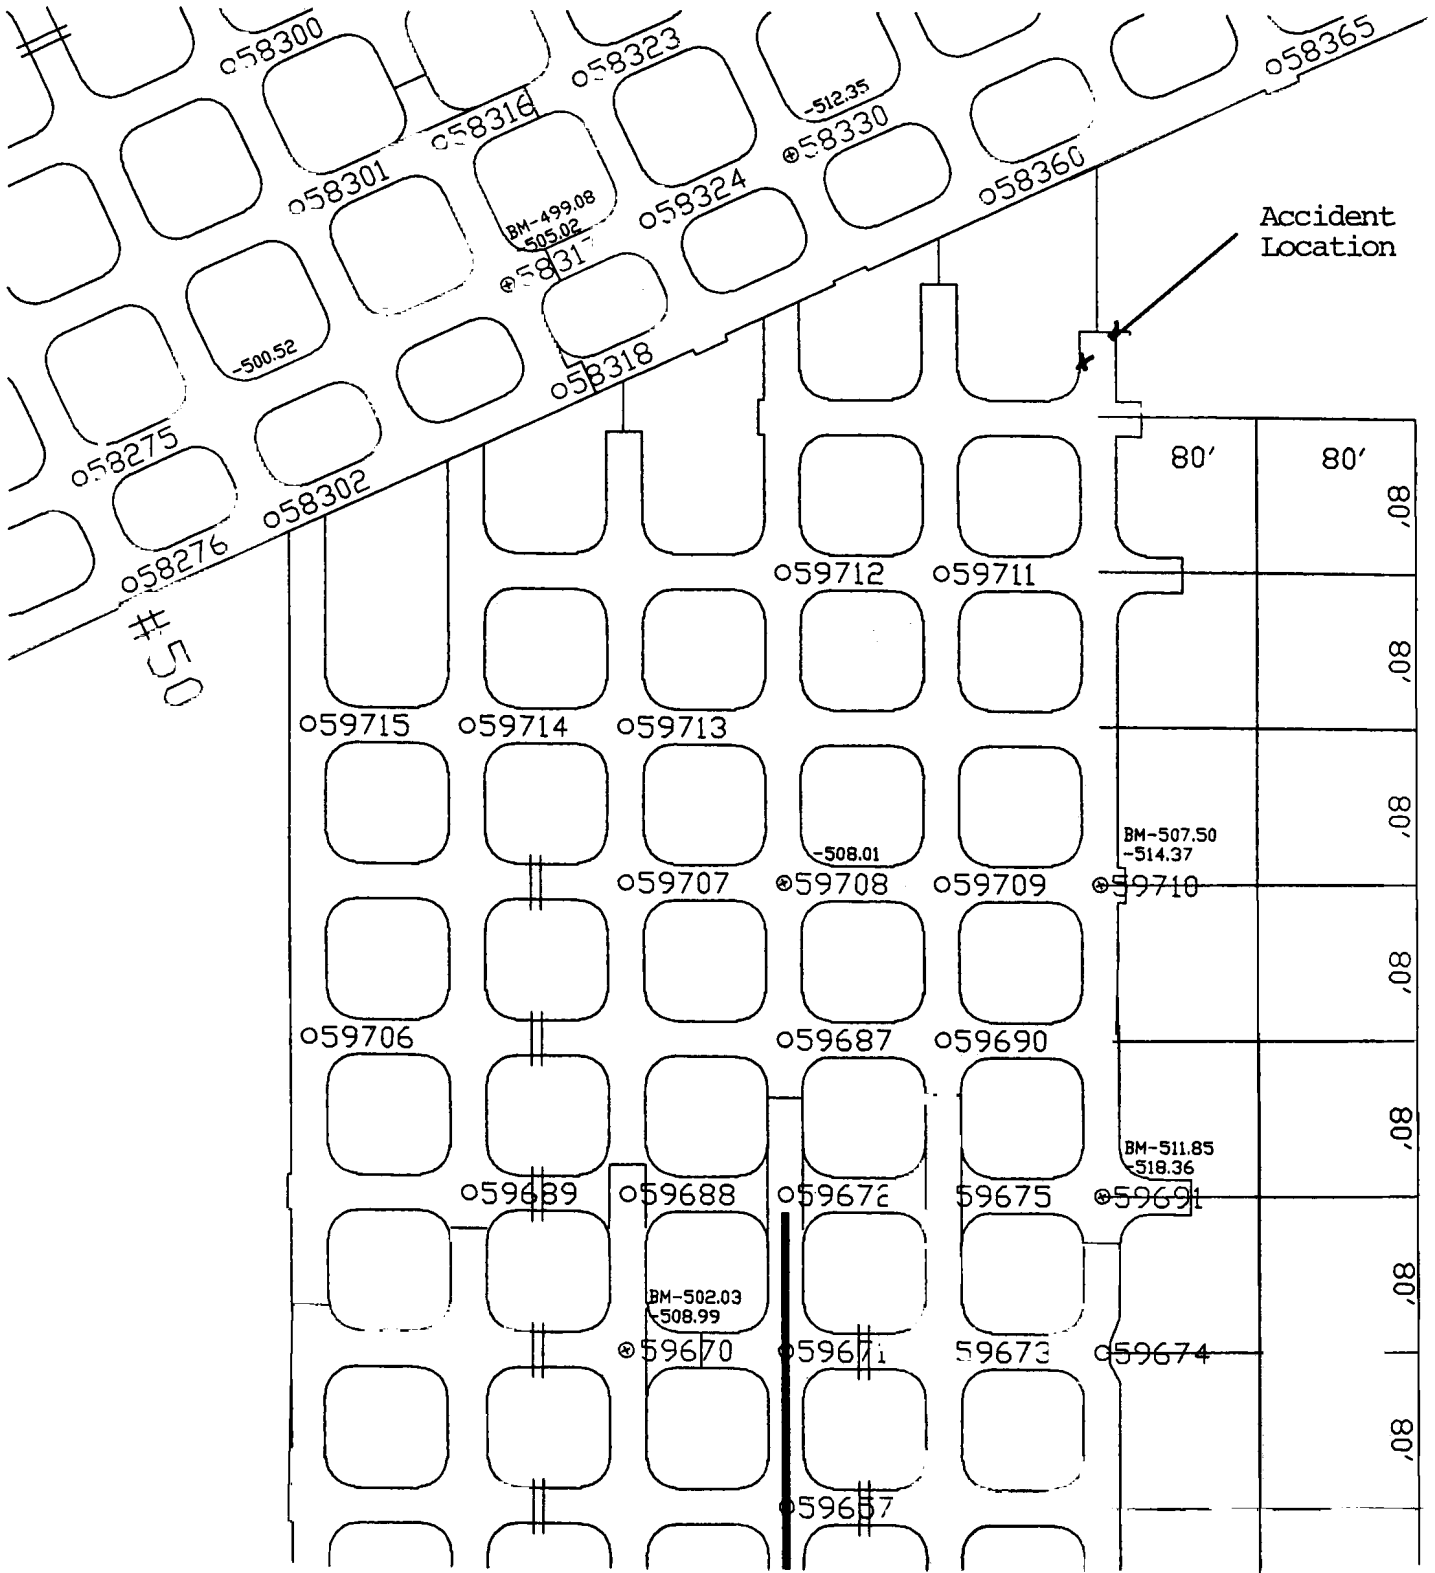
APPENDIX C

Appendix A is a list of persons who participated in the investigation. Appendix B is a list of persons interviewed on a non-confidential basis, or who provided information relevant to the investigation. Underground investigative procedures included mapping of the accident site. Appendix C depicts the extent of mining in the B-2 working section. Appendix D depicts the area of the immediate accident site.

The B-2 working section was originally an eight-entry room and pillar section, with a crosscut centerline spacing of 80 feet. The unit had dropped No. 8 Entry on January 16, 2003, and dropped No. 1 Entry on January 22, 2003, due to problems with ventilation. The B-2 unit had been driven in a southeast direction, but had experienced adverse roof conditions. The working section was subsequently turned on a northeast angle to help control the roof and rib conditions. The B-2 working section was mining toward an old B-2 worked out panel, and had been experiencing severe adverse roof and rib conditions. While working in the old B-2 panel, adverse roof conditions and some squeezing were encountered. The roof and rib conditions worsened as the B-2 working section got closer to the old panel. When mining in the No. 7 Entry, a layer of the immediate mine roof, approximately 24 inches in thickness, fell onto the continuous mining machine and was subsequently loaded out and the entry trimmed.

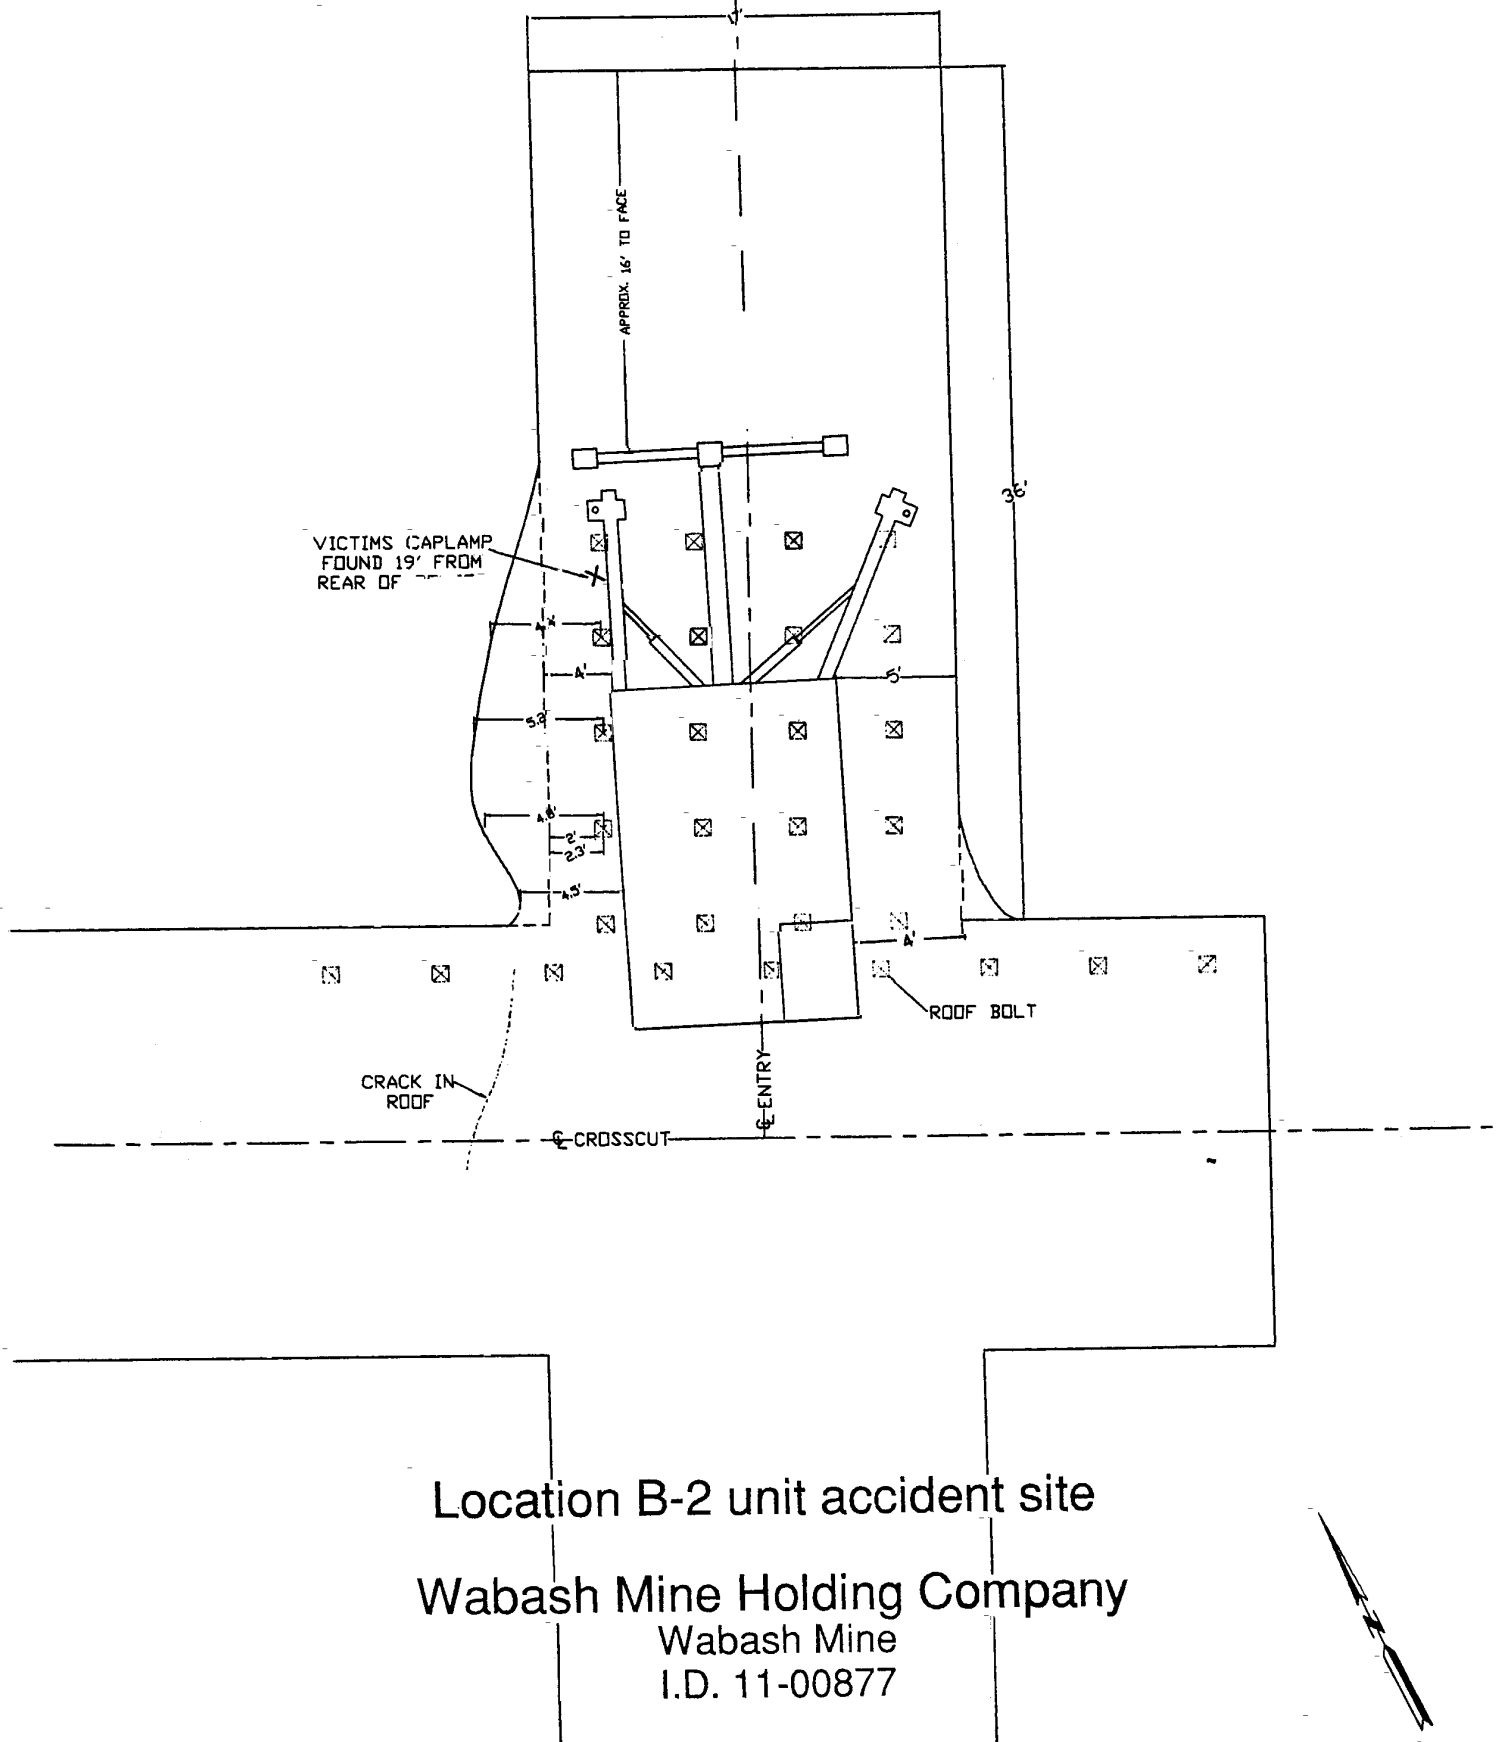
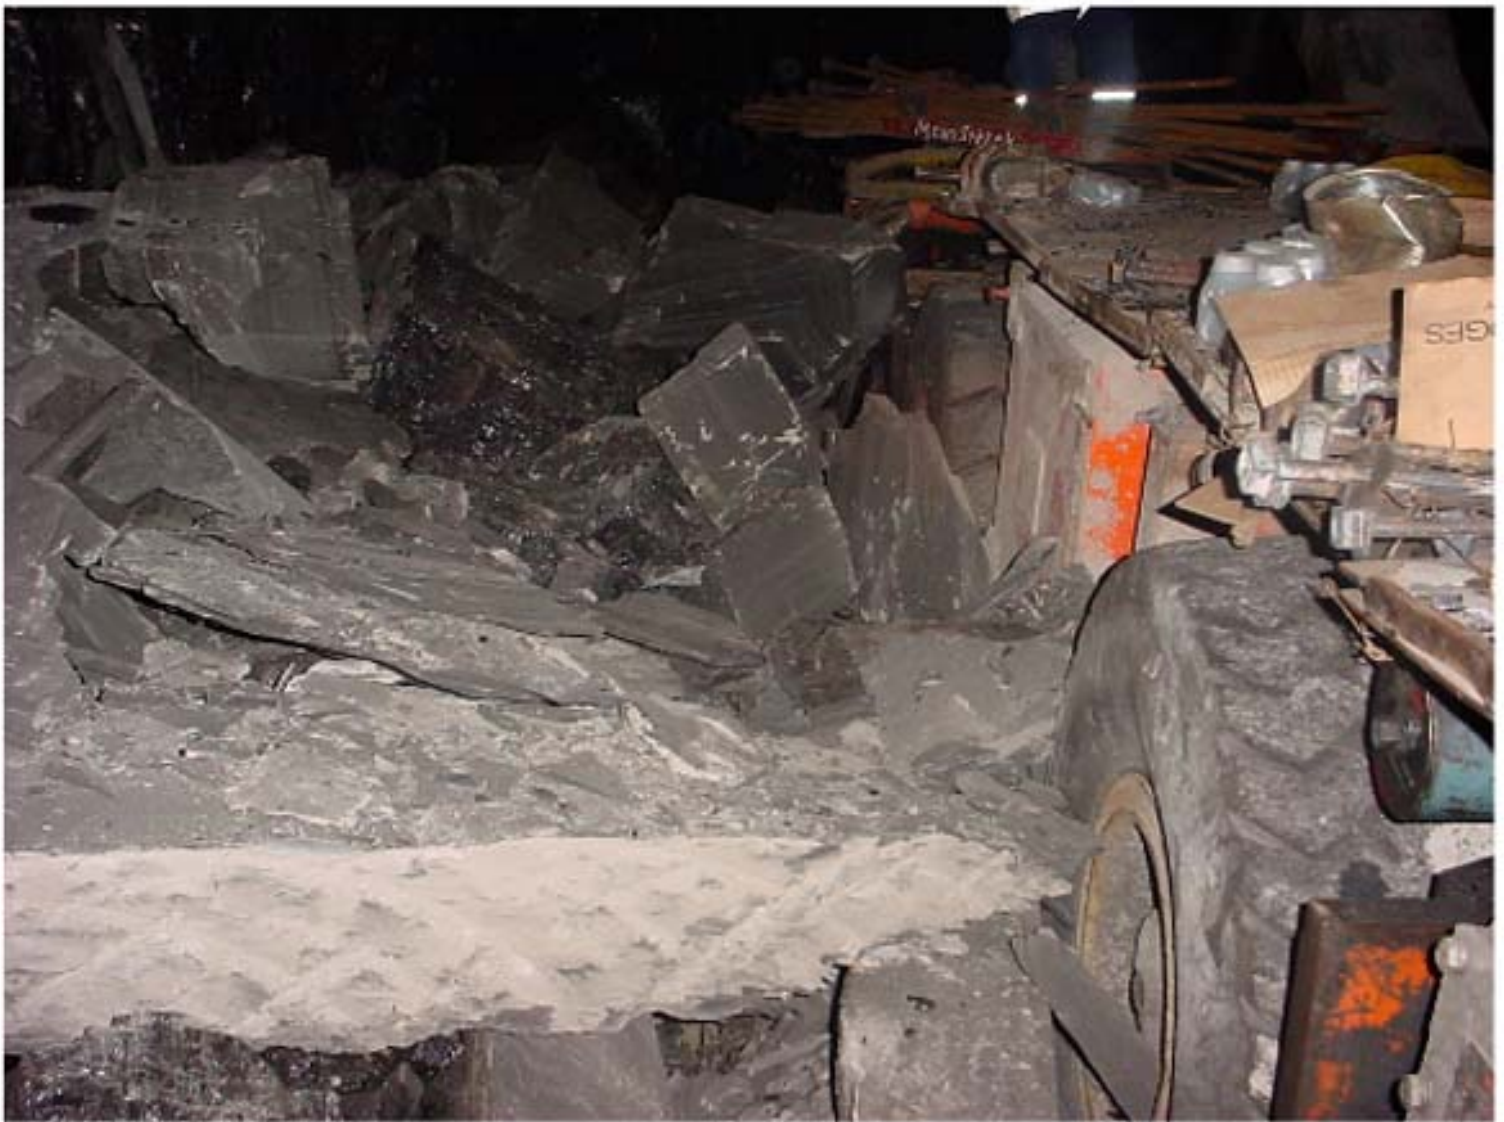
APPENDIX D

The accident occurred in the No. 7 Entry on the B-2 working section, 240 feet in by survey station 59710. The coal and rock rib that covered Neese measured approximately 30 feet in length, 8 feet in height, and approximately 24 inches in thickness. The coal and rock that fell had an approximate weight of 23 tons.

Neese was walking along the left side of the roof-bolting machine, while Garner trammed the machine forward to install the next row of roof bolts when the rib fell. The left side of the roof-bolting machine was approximately 3.5 feet from the original rib at the time of the accident. The No. 7 Entry had been mined to a depth of approximately 35 feet.
